Private At-Grade Road Crossing at T Lazy S Ranch– northeast of Battle Mountain (UP/Track No. 2 - MP 600.56-Elko Subdivision-UP/WP Mainline)

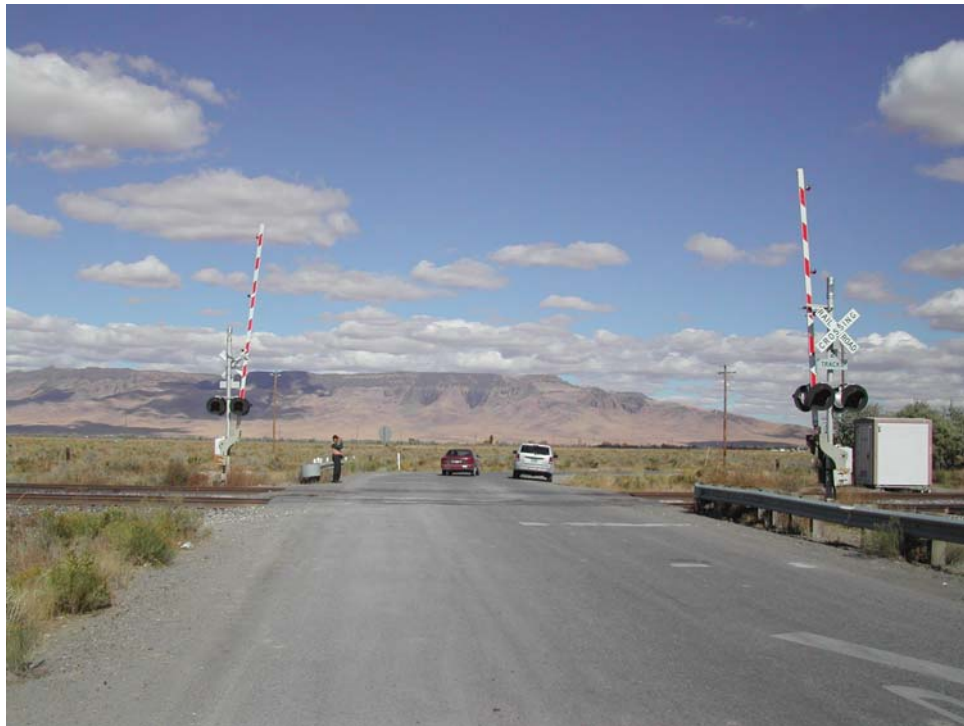
**Figure 8: North Second Street crossing Track No 1 –View looking north**

The Track No.1 Westward crosses North Second Street west of Battle Mountain. The track crossing is made up of rubber panels through this paved road. The rubber panels, although relatively new, show some deterioration due primarily to underlying subgrade instability. Some of the rubber panels on the south side of the crossing are not flush with the AC pavement, indicating deterioration of the trackbed. This condition requires minor maintenance to stabilize the trackbed and refasten the rubber

The crossing structure appears to have subsided, as shown by fine aggregate rising to the surface of the timber crossties. This condition is due primarily to heavy vehicular traffic. There are train activated warning devices; gates, mast mounted flashing lights, and bells.

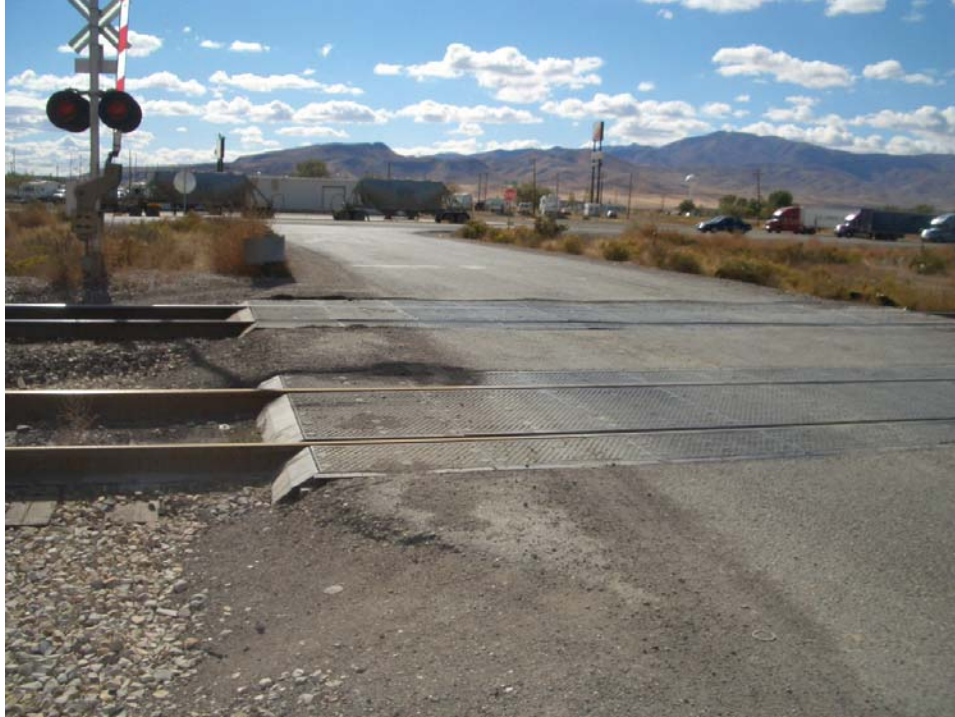
**Figure 9: Rubber Crossing Panels at North Second Street- view looking south**

panels. The track in the area is ballasted using 119 RE rails sections continuously welded and fastened to timber ties by cut spikes. The ties spacing is 19 inches through the crossing. The track grade is relatively flat, with grades between 0.05% and 0.07%. Ballast material is mostly crushed river rock.

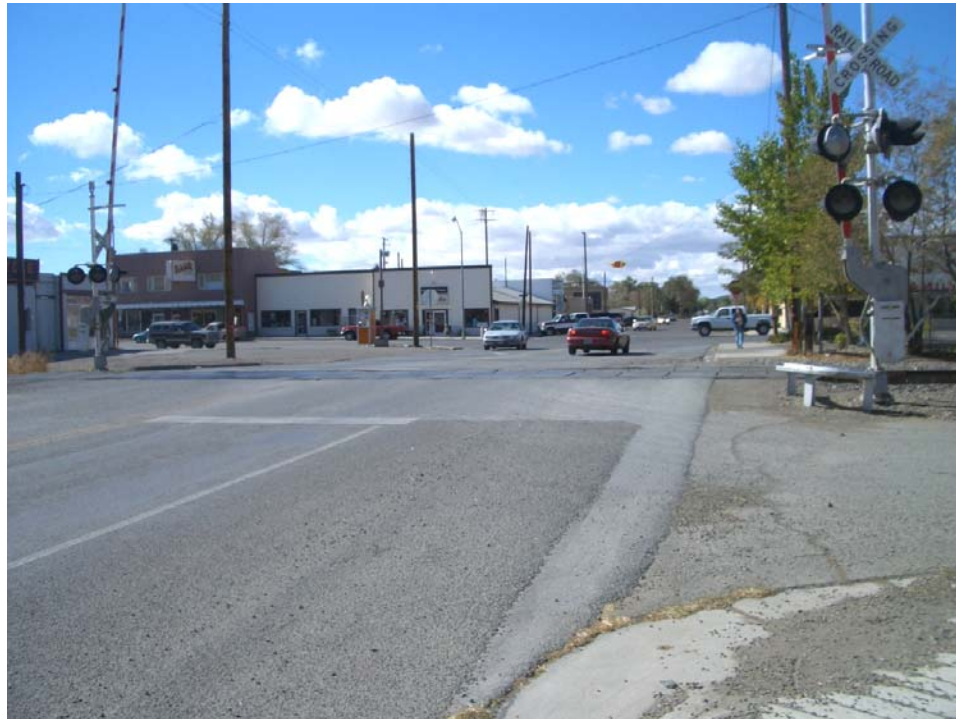
**Figure 10: Reese Street Crossing Track No. 1 - View looking south towards Front Street, which is parallel to the track**

The Track No.1 Westward crosses Reese Street in the middle of Battle Mountain. The track crossing is made up of rubber panels through this paved road. The rubber panels, although relatively new, show some deterioration mainly due to underlying subgrade instability. Rubber panels on the both side of the track are not flush with the AC pavement indicating deterioration of the trackbed. This condition requires minor maintenance to stabilize the trackbed and refasten the rubber panels. The track in the area is ballasted using 119 RE rails sections continuously welded and fastened to timber ties by cut spikes. The ties spacing is 19 inches through the crossing. The track grade is relatively flat. Ballast material is mostly crushed river rock possibly coming from local source.

The crossing structure appears to have subsided, as shown by fine aggregate rising to the surface of the timber crossties. This condition is primarily due to heavy vehicular traffic through the crossing. There are train activated warning devices, gates, mast mounted flashing lights, and bells.

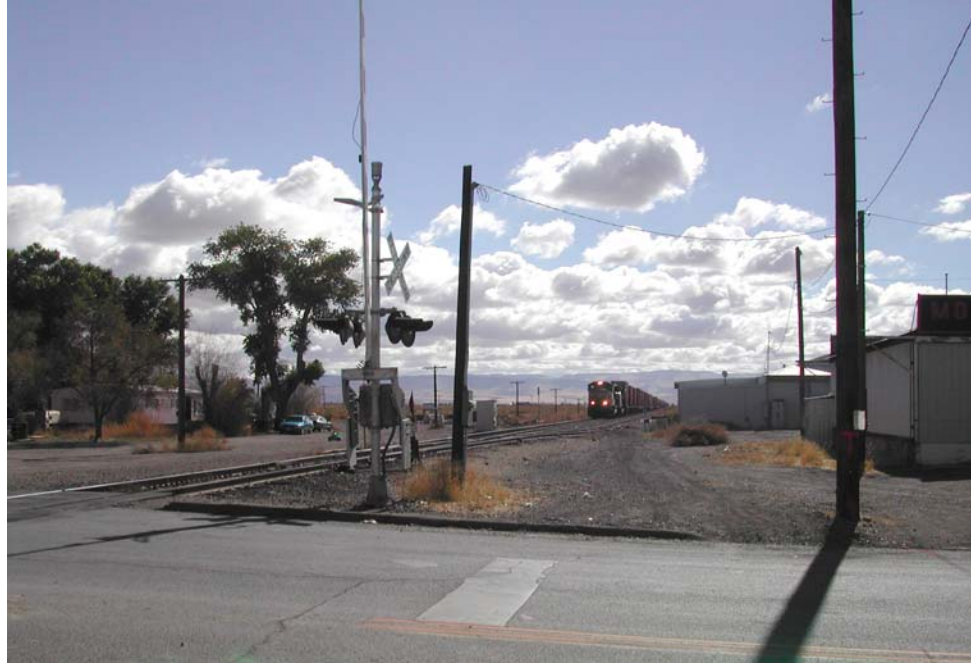
**Figure 11: Active Siding east of Reese Crossing**

Just east of Reese crossing there is a turnout to an active siding with manual switches coupled with a switch derail. The turnout appears to be in the trailing movement assuming the predominant train passing through is westward. This siding is laid out easterly to a stub end, for a total of approximately 2 miles in length.

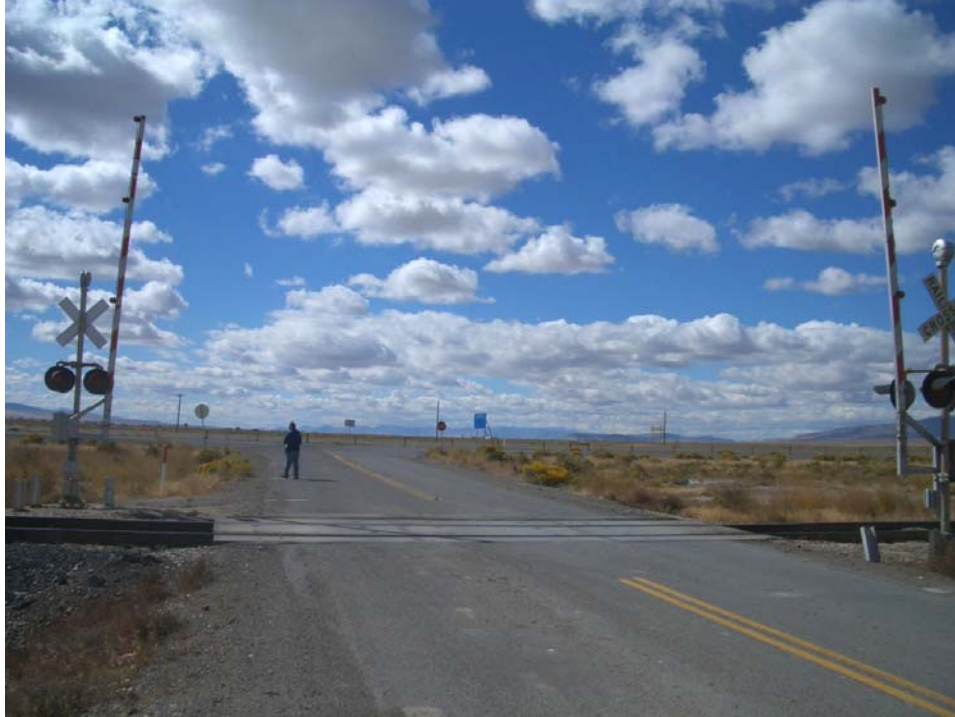
**Figure 12: Muleshoe Ranch Road Crossing Track No. 1 – View looking south towards I-80**

The concrete panels are relatively new and in generally good condition. The track immediately ahead of the crossing shows some deterioration mainly due to underlying subgrade instability. This condition requires minor maintenance to stabilize the trackbed and bring the top of rail profile to its original design elevation. The track in the area is ballasted using 119 RE rails sections continuously welded and fastened to timber ties by cut spikes. The ties spacing is 19 inches through the crossing. The track grade is relatively flat. Ballast material is mostly crushed river rock. There are train activated warning devices, gates, mast mounted flashing lights, and bells.

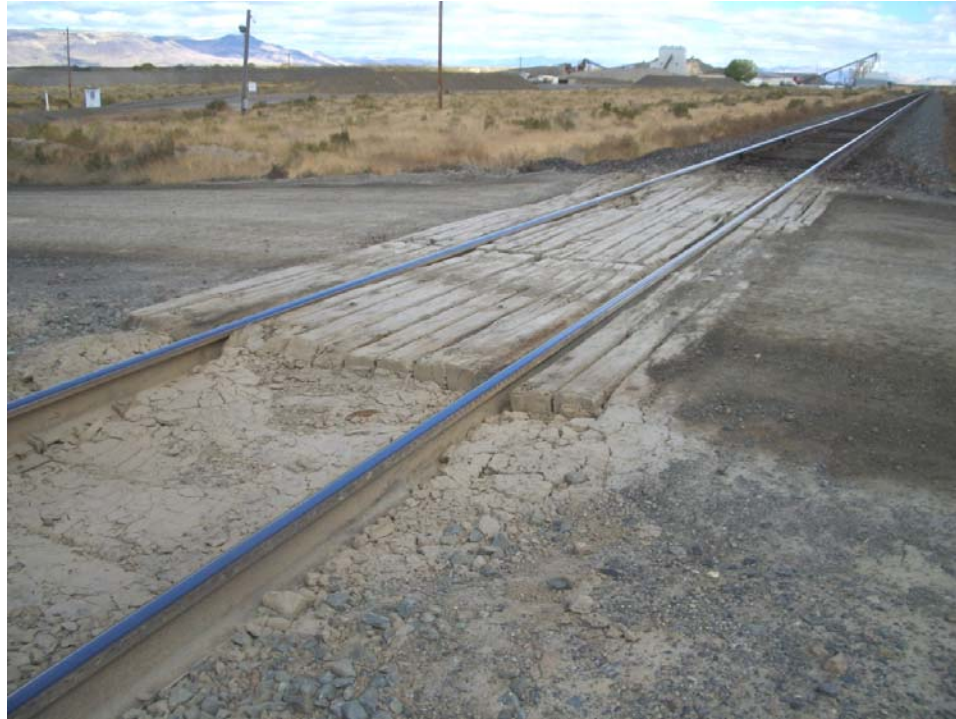
The timber panels show significant deterioration especially at the ends. Some timber crossing panels are loose and bolts are missing, which generally requires major maintenance efforts. The track is ballasted using 136 RE rails sections continuously welded and fastened to timber ties by cut spikes. The ties spacing is 19 inches through the crossing. The track grade is relatively flat, with grades between 0.03% and 0.035%. Ballast material is crushed river rock.

The crossing structure appears to have subsided, as shown by fine aggregate rising to the surface of the timber crossties. This condition is primarily due to heavy vehicular traffic through the crossing. There are train activated warning devices, gates, mast mounted flashing lights, and bells.

**Figure 13: Baker-Hughes-INTEQ Crossing – looking towards the facility –View shows timber panels and deteriorated track substructure**

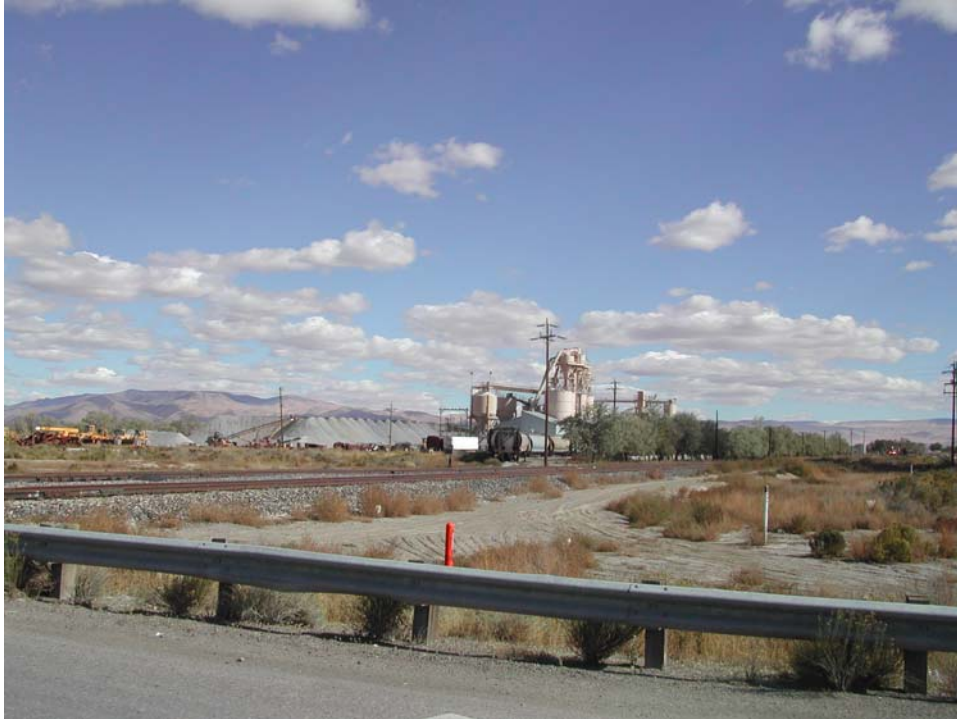
**Figure 15: Crossing near MI Battle Mountain Plant**

North Second Street has a two track crossing. The second track is an industrial siding servicing the MI Battle Mountain Plant, an aggregate batching plant. This is also an area where switching movements are made for local service.
