Muleshoe Ranch Road Crossing – East of Battle Mountain (UPRR MP 478.45-Salt Lake Subdivision-Main Route)

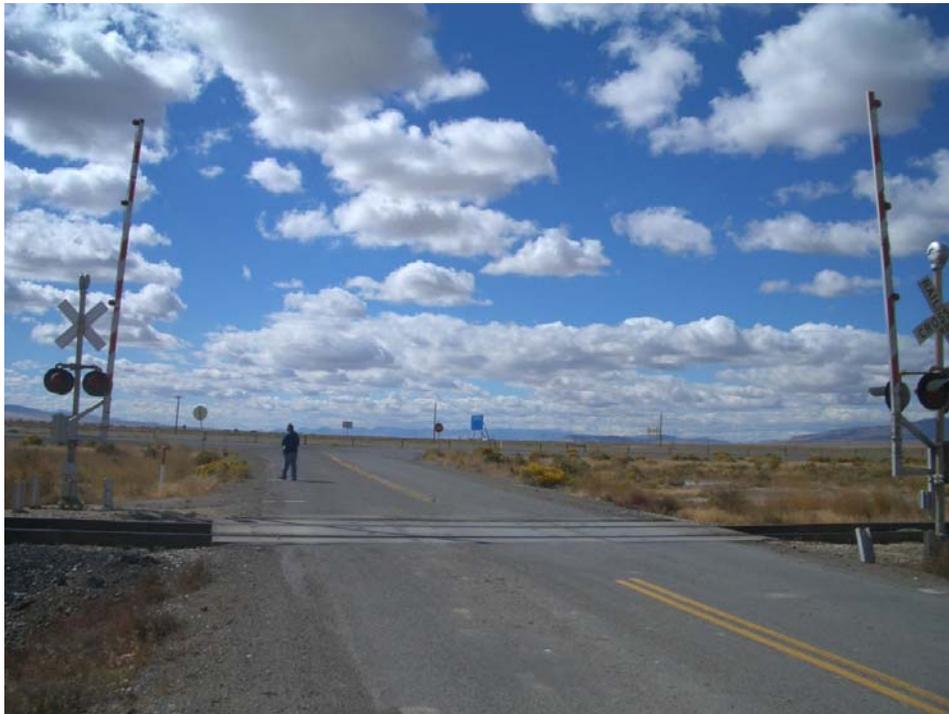
The concrete panels are relatively new and in generally good condition. The track immediately ahead of the crossing shows some deterioration mainly due to underlying subgrade instability. This condition requires minor maintenance to stabilize the trackbed and bring the top of rail profile to its original design elevation. The track in the area is ballasted using 119 RE rails sections continuously welded and fastened to timber ties by cut spikes. The ties spacing is 19 inches through the crossing. The track grade is relatively flat. Ballast material is mostly crushed river rock. There are train activated warning devices, gates, mast mounted flashing lights, and bells.

Figure 10 Muleshoe Ranch Road Crossing Track No. 1 – View Looking South Towards I-80

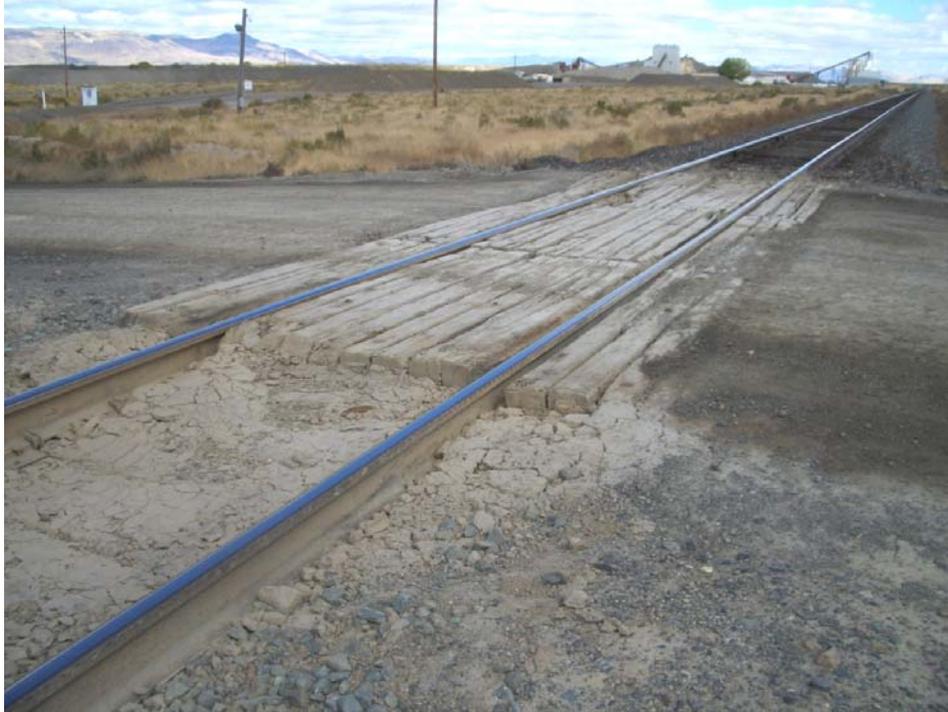
The timber panels show significant deterioration especially at the ends. Some timber crossing panels are loose and bolts are missing, which generally requires major maintenance efforts to repair. The track is ballasted using 136 RE rails sections continuously welded and fastened to timber ties by cut spikes. The tie spacing is 19 inches through the crossing. The track grade is

The crossing structure appears to have subsided, as shown by fine aggregate rising to the surface of the timber crossties. This condition is primarily due to heavy vehicular traffic through the crossing. There are train activated warning devices, gates, mast mounted flashing lights, and bells.

Figure 11 Baker-Hughes-INTEQ Crossing – Looking Towards the Facility – View shows timber panels and deteriorated track substructure

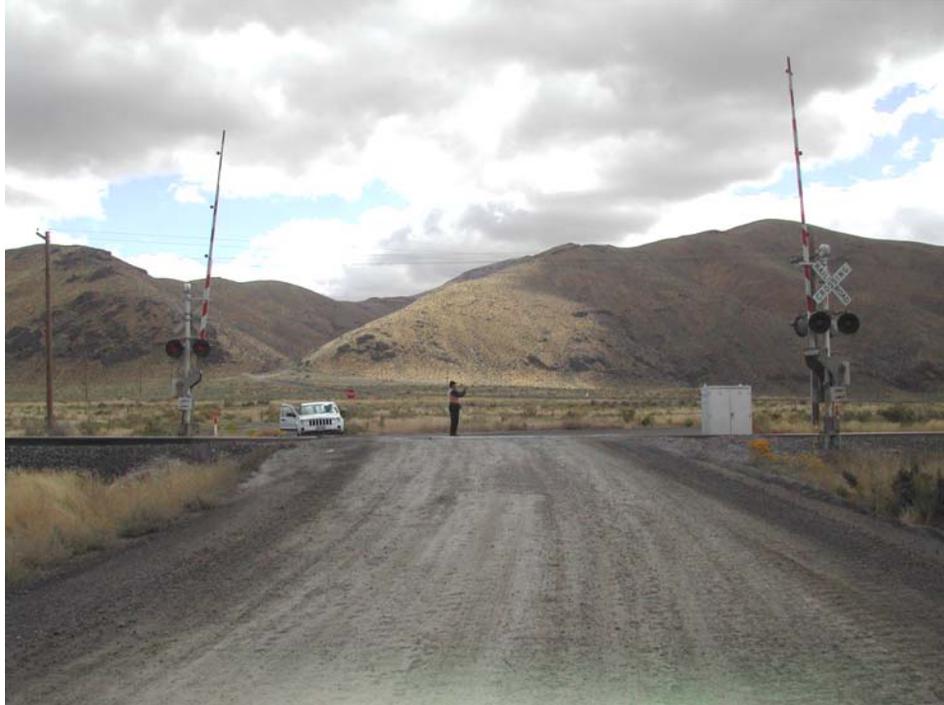
Figure 12 Baker-Hughes-INTEQ Crossing – Looking South Towards I-80

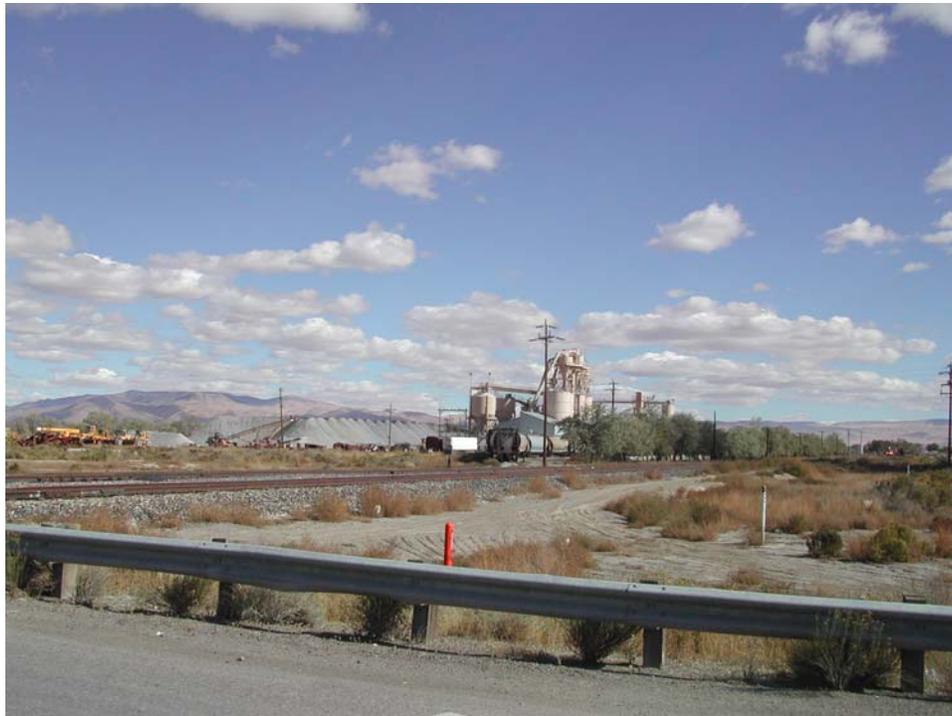
Figure 13 Crossing Near MI Battle Mountain Plant
