1.0 Rail Corridor Characteristics

2.0. Location and Condition of Existing Crossings, Sidings, and Switching Areas

2.1 Existing Grade Crossings

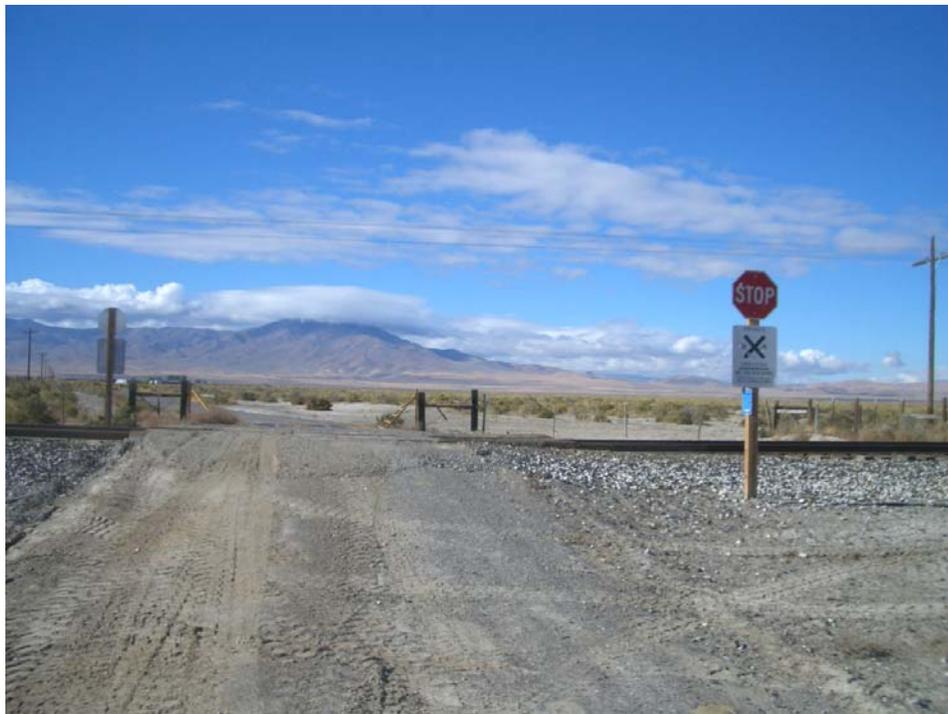
Mote Road at Russell (25 Ranch Road per FRA Database)
(UP/Track No. 2 -MP 582.12-Elko Subdivision-UP/WP Mainline)

Figure 1 Mote Road Crossing UPRR Track No. 2 Eastward - View Looking South

Track No.2 Eastward crosses Mote Road at Russell. The track crossing is made of solid timber panels through this dirt road. The timber panels show significant deterioration, especially at the ends. Some timber crossing panels are loose and bolts are missing, which generally requires a major maintenance effort to repair. The track is ballasted using 136 RE rails sections continuously welded and fastened to timber ties by cut spikes. The ties spacing is 19 inches through the crossing. The track grade is relatively flat, with grades between 0.05% and 0.07%. Ballast material is a combination of crushed dark volcanic rock and crushed river rock.

The crossing structure appears to have subsided. This is indicated by fine aggregate rising to the surface of the timber crossties, a condition primarily due to heavy vehicular traffic. There is no active warning device, but there are crossbucks before and after the crossing.

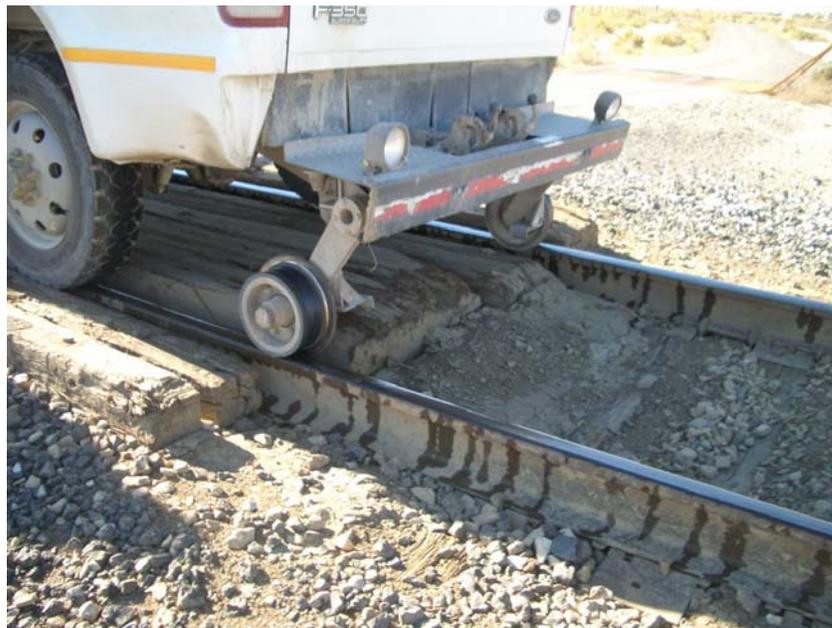
Figure 2 Timber Panels on Track No. 2 Eastward at Mote Road Crossing

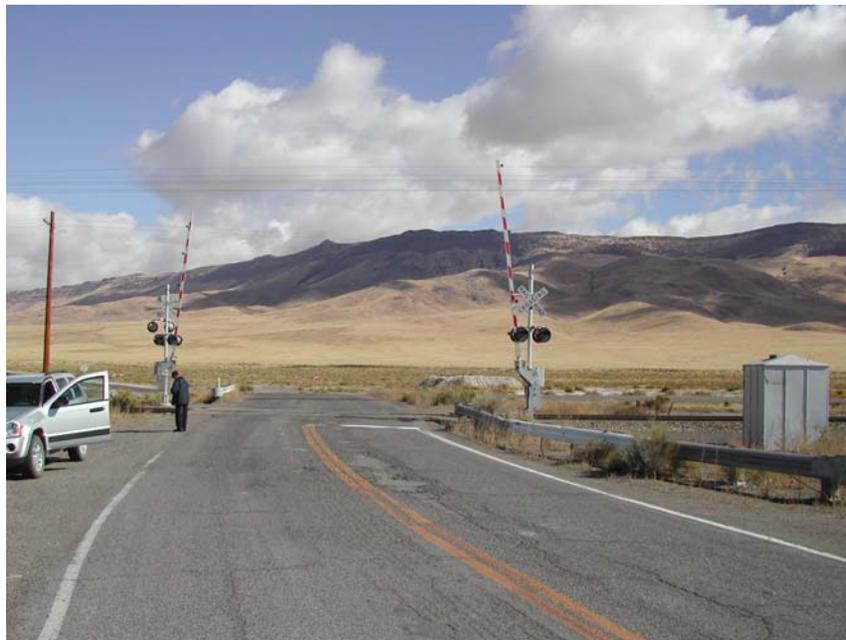
State Highway 35 (North Battle Mountain Road)
(UP/Track No. 2 - MP 589.05-Elko Subdivision-UP/WP Mainline)

Track No.2 Eastward crosses State Highway (SH) 35 at North Battle Mountain. The track crossing is made up of reinforced concrete panels through the paved SH 35.

The track in this area is ballasted using 136 RE rail sections continuously welded and fastened to timber ties by cut spikes. The ties spacing is 19 inches through the crossing. The track grade is relatively flat, with a grade between 0.05% and 0.07%. Ballast material is a combination of crushed dark volcanic rock and crushed river rock. There are train activated warning devices, gates, mast mounted flashing lights, and bells. SH 35 is the main road leading from Battle Mountain to agricultural lands farther north.

Figure 3 SH 35 Crossing UPRR Track No 2 at North Battle Mountain – DOT Number 833442F

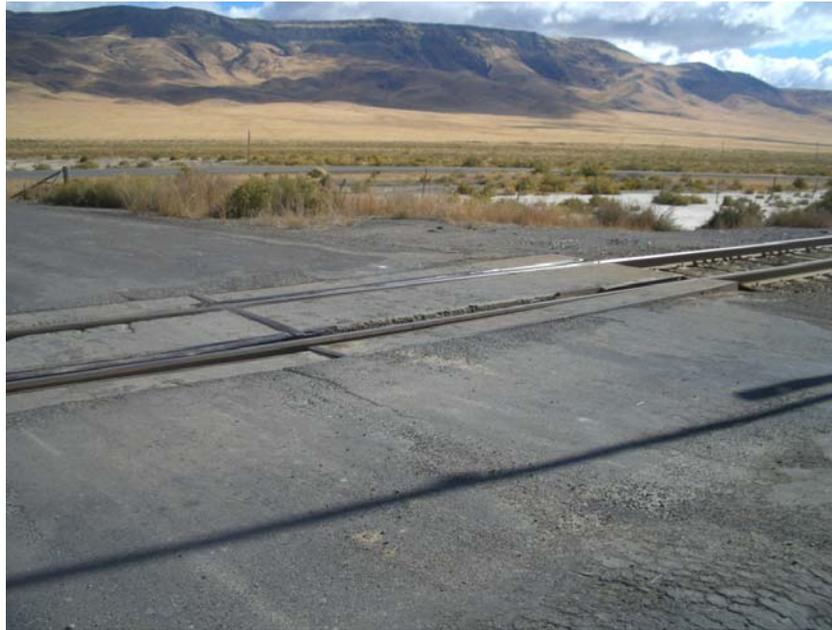
The concrete crossing panel has metal edges that make up the wheel flange ways. There is noticeable deterioration of the crossing panels, with the metal edges separated from the concrete panels. This condition indicates instability of the panel attachment to the timber ties and is primarily attributable to subsidence and the presence of moisture. Heavy highway traffic contributes to this condition as further indicated by the spalling¹ of the asphalt concrete (AC) paving before and after the crossing.

**Figure 4 Concrete Crossing Panels through the Paved State Highway 35
Crossing UPRR Track No 2 at North Battle Mountain – DOT Number
833442F**

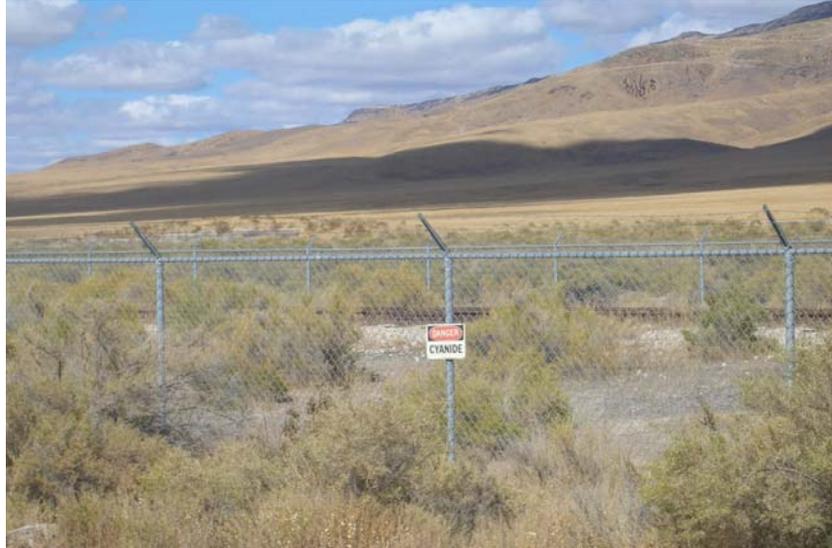
Industry Spur to FMC Distribution Facility East of North Battle Mountain
(UP/Track No. 2 - MP 590 (approximate) -Elko Subdivision-UP/WP Mainline)

FMC Distribution, located east of North Battle Mountain, has an industrial spur. The spur crosses the dirt access road to the facility. The spur is relatively new as evidenced by newer concrete crossing panels attached to timber ties on ballasted track.

Figure 5 FMC Distribution –Industrial Spur– Track and Crossing Concrete Panels in Good Condition

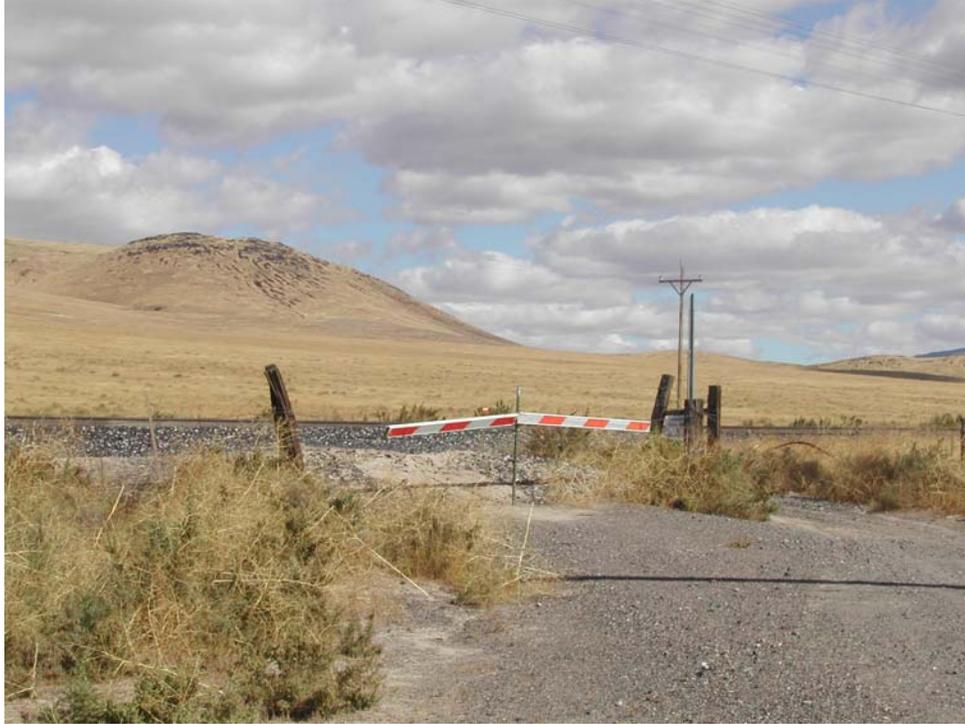
Private At-grade Crossing east of FMC Facility (UP/Track No. 2 -MP 744.5-
Elko Subdivision-UP/WP Mainline)

This at-grade crossing has been closed, although the access road leading to it has remained intact to serve agricultural lands south of the track. The road can also be used for emergency access to the track.

Figure 6 Closed Private Access Road Leading to a Previous At-Grade Crossing of the Tack No 2 – East of FMC Facility

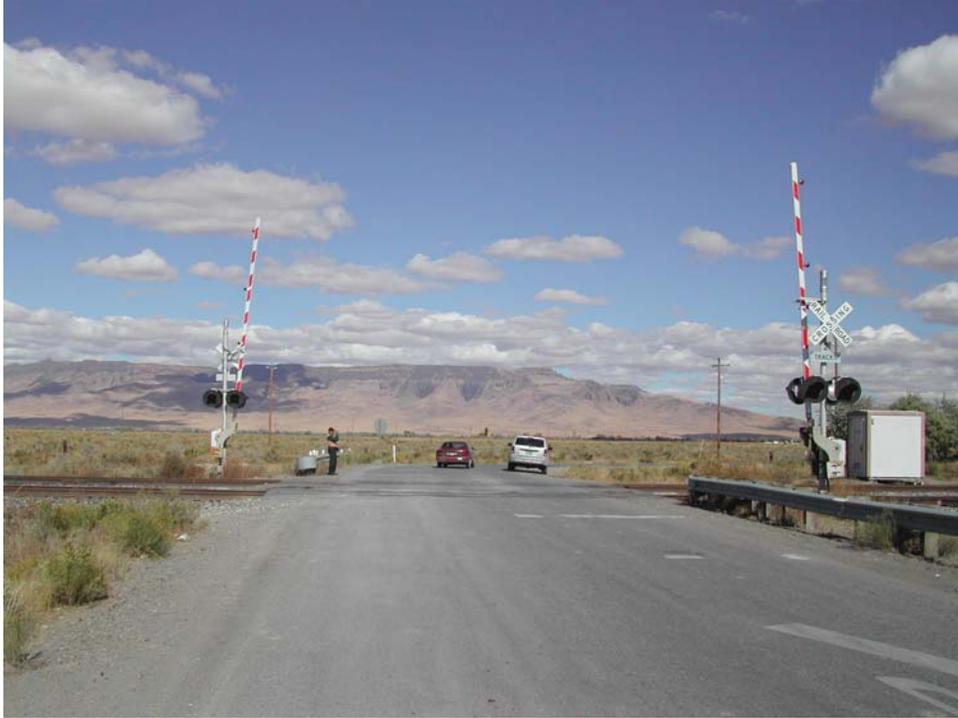
North Second Street Crossing at Front Street – Battle Mountain (UPRR MP 475.05-Elko Subdivision-Overland Route)

The Track No.1 Westward crosses North Second Street west of Battle Mountain. The track crossing is made up of rubber panels through this paved road. The rubber panels, although relatively new, show some deterioration due primarily to underlying subgrade instability. Some of the rubber panels on the south side of the crossing are not flush with the AC pavement, indicating deterioration of the trackbed. This condition requires minor maintenance to stabilize the trackbed and refasten the rubber panels. The track in the area is ballasted using 119 RE rails sections continuously welded and fastened to timber ties by cut spikes. The tie spacing is 19 inches through the crossing. The track grade is relatively flat, with grades between 0.05% and 0.07%. Ballast material is mostly crushed river rock.

The crossing structure appears to have subsided, as shown by fine aggregate rising to the surface of the timber crossties. This condition is due primarily to heavy vehicular traffic. There are train activated warning devices; gates, mast mounted flashing lights, and bells.

Figure 7 North Second Street Crossing Track No 1 – View Looking North

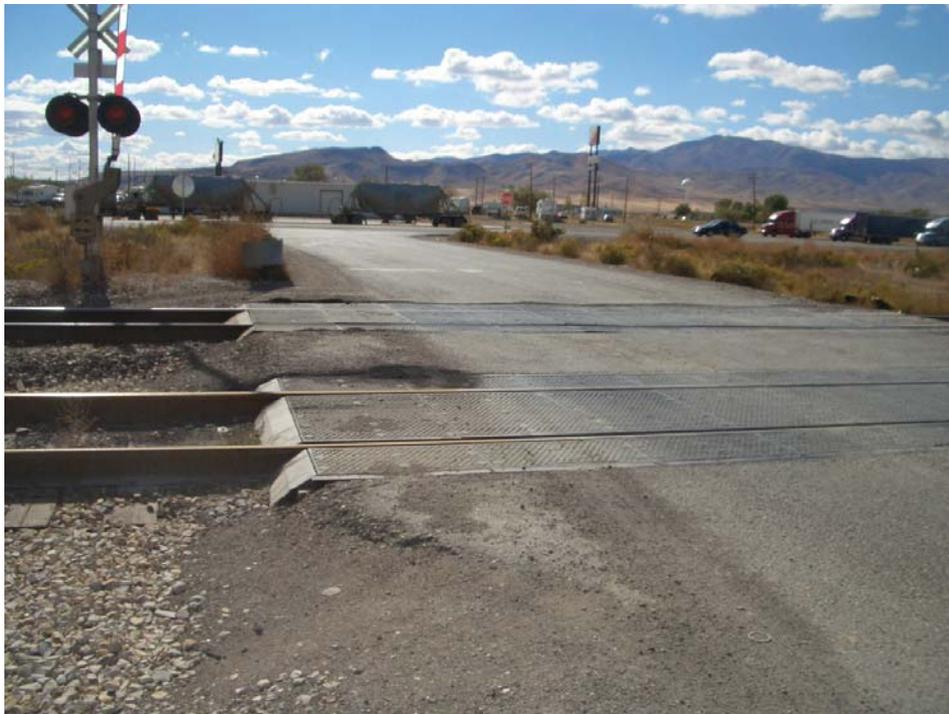
Figure 8 Rubber Crossing Panels at North Second Street- View Looking South

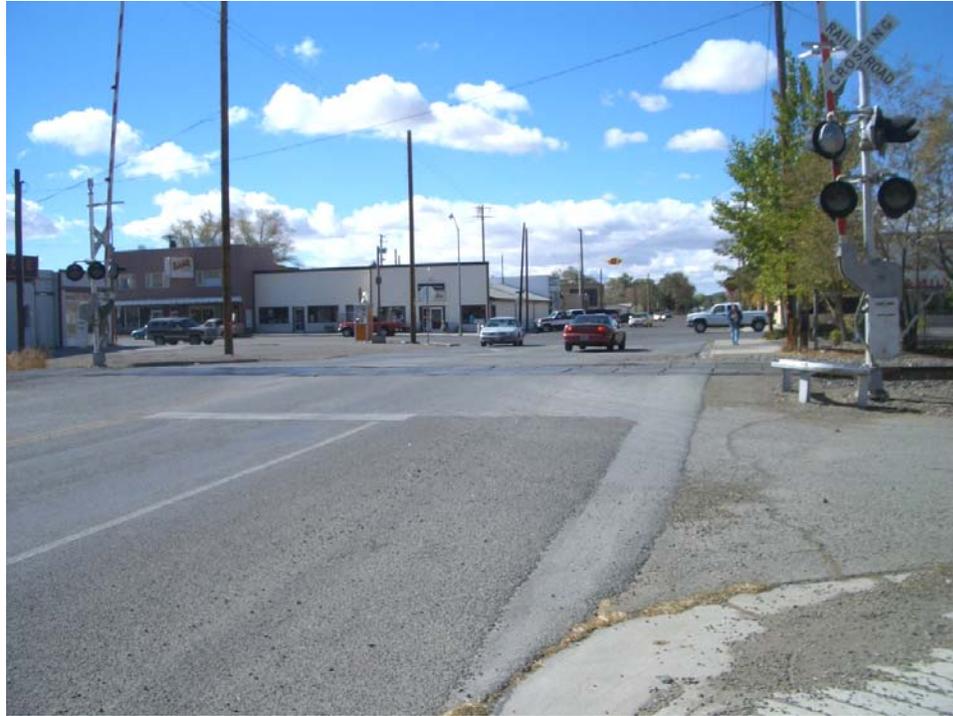
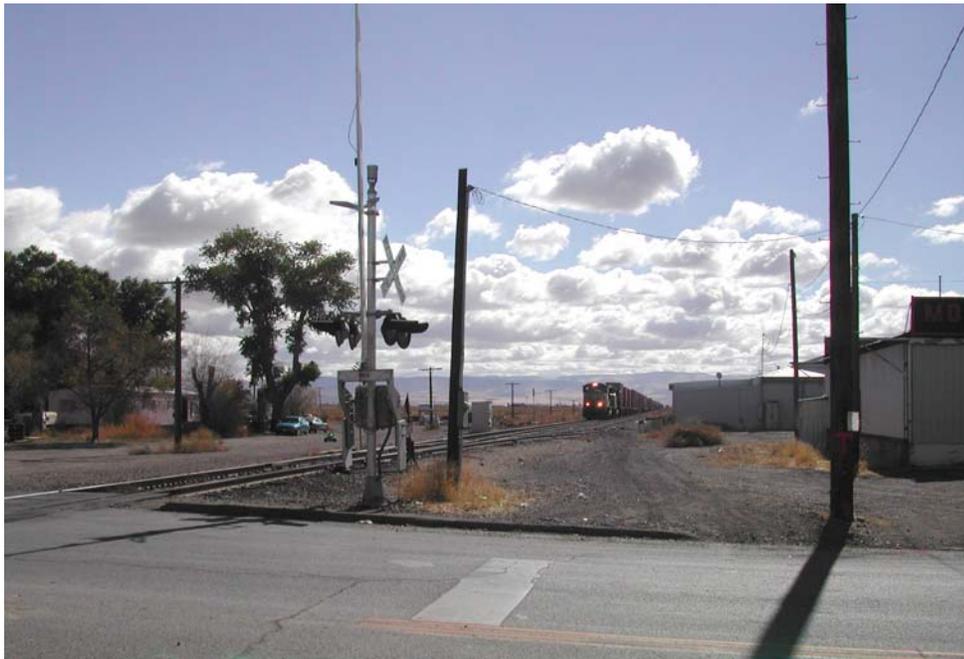
Just east of the Reese crossing there is a turnout to an active siding with manual switches coupled with a switch derail. The turnout appears to be in the trailing movement assuming the predominant train passing through is westward. This siding is laid out easterly to a stub end, for a total of approximately 2 miles in length.

Figure 9 Active Siding east of Reese Crossing
