Final Report
EVALUATION OF
RAILROAD GRADE CROSSINGS

For
Lander County
Battle Mountain, Nevada

By
ETS Pacific, Inc.
3030 S.W. Moody Avenue, Suite 101
Portland, Oregon 97201
(503)222-5840

January 21, 1994

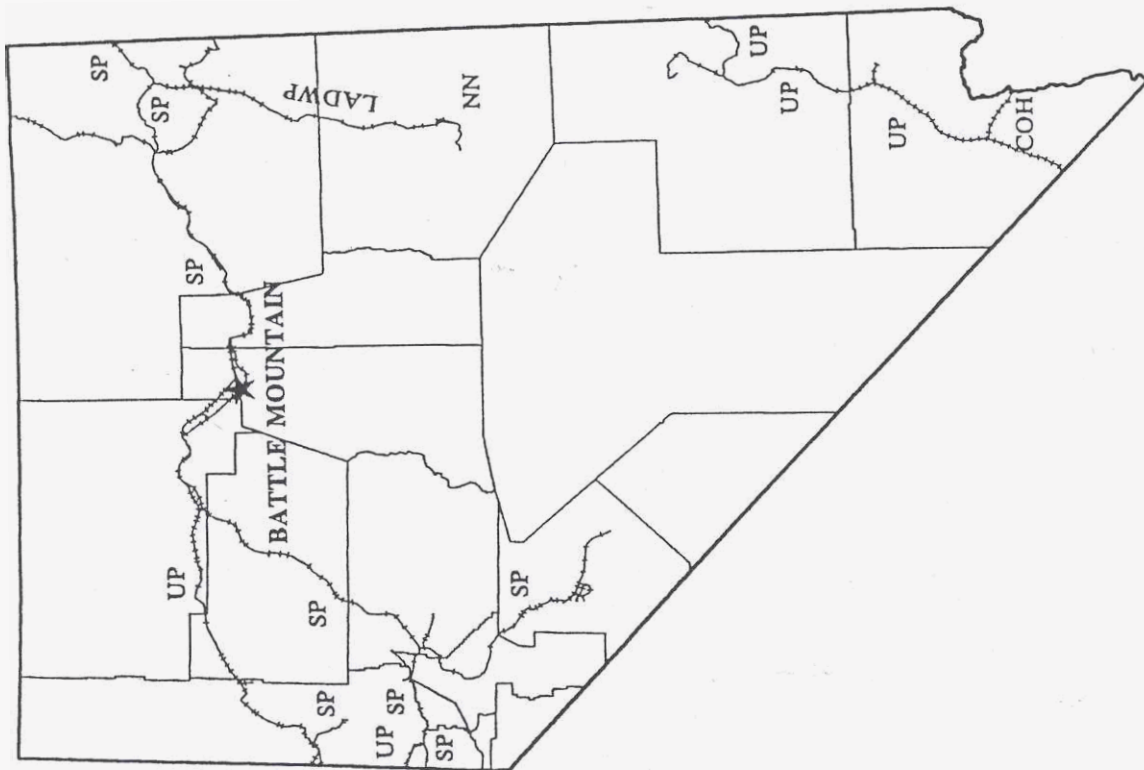
FIGURE 1

EXISTING NEVADA RAIL SYSTEM

- KEY**
- UP - UNION PACIFIC
 - SP - SOUTHERN PACIFIC
 - NN - NEVADA NORTHERN
 - LADWP - LOS ANGELES WATER AND POWER
 - COH - CITY OF HENDERSON

Nevada has three main line routes (Figure 1), one owned by the Southern Pacific Transportation Company (SPTCo) and two owned by the Union Pacific Railroad (UPRR). Two of the main line routes pass through northern Lander County and Battle Mountain. It is possible that this corridor segment could be used for waste shipments directly to the repository or a MRS facility.
